TECHNICAL REPORT NO. 2-580

+6  
2 SAVANNAH HARBOR INVESTIGATION AND MODEL STUDY

# RESULTS OF TESTS OF BANK EROSION IN NORTH CHANNEL

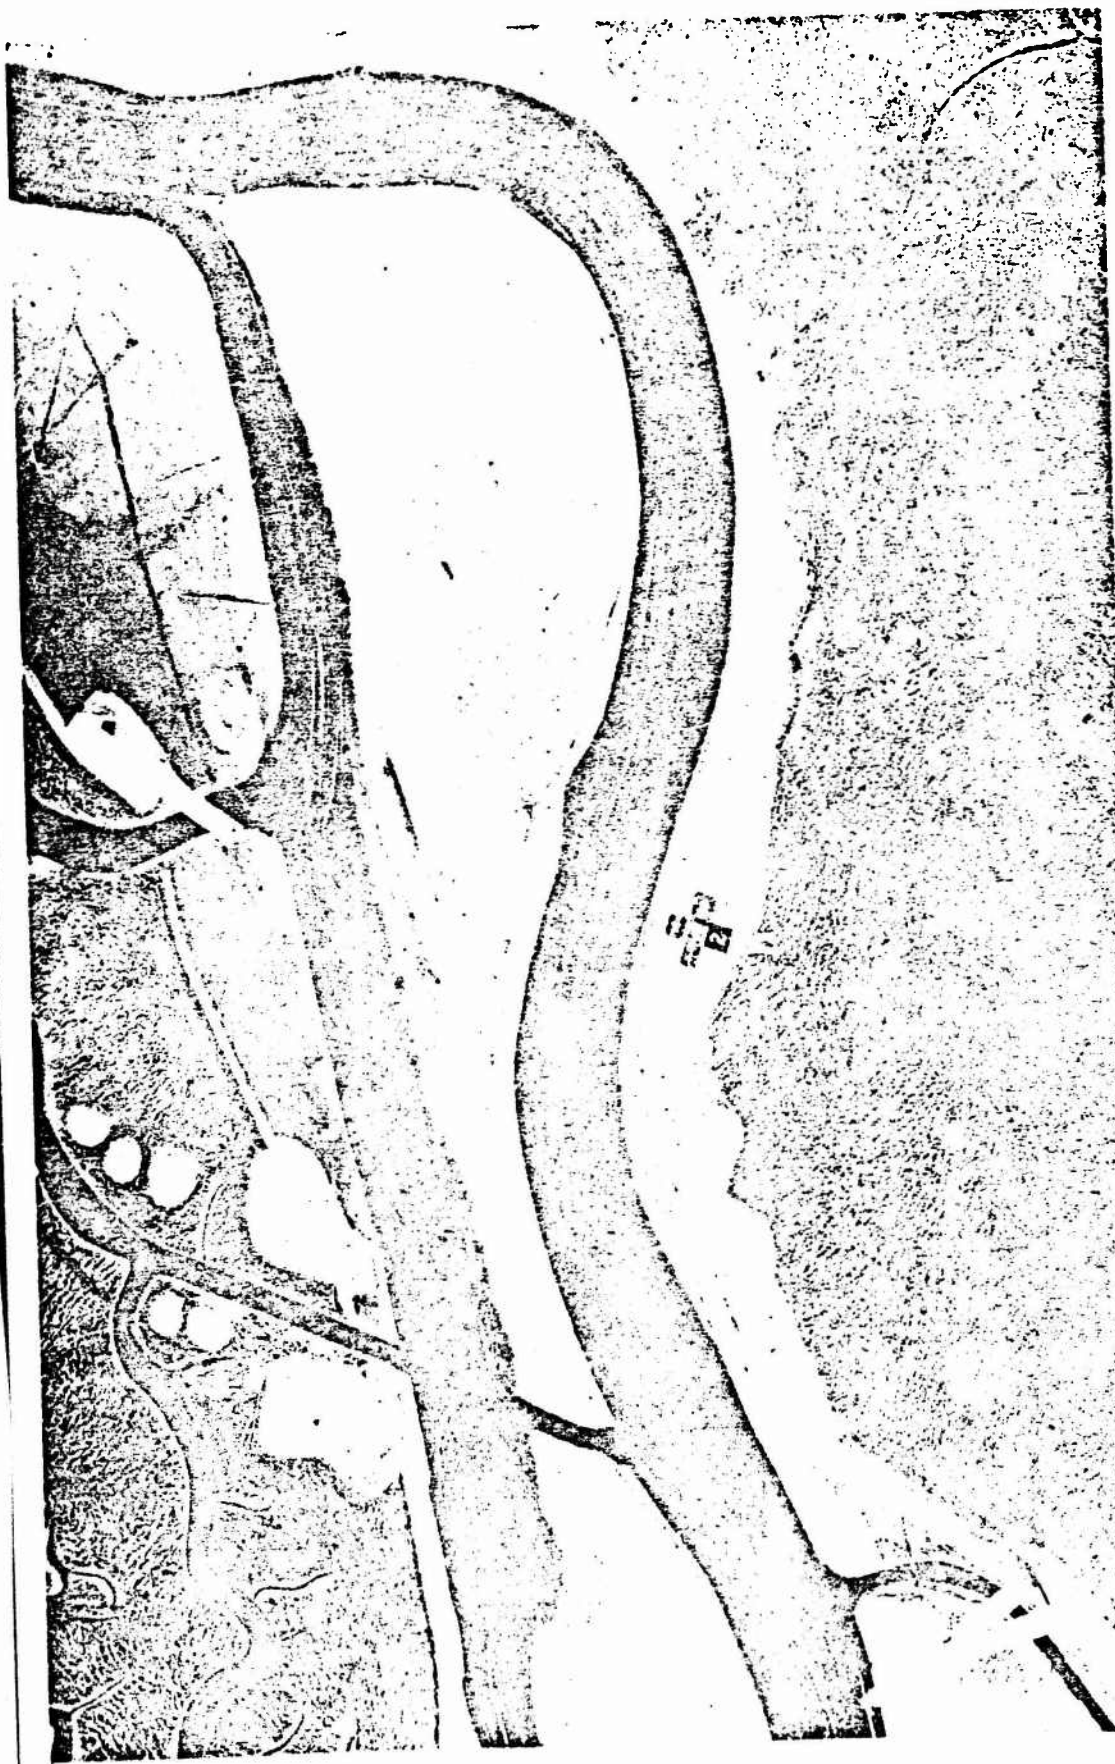
Photograph 3. Surface current directions and velocities for 1964 channel conditions. Hour 2, ebb tide

8. Comparison of photographs 1-13, which show surface current directions and velocities for the 1964 channel conditions at hourly intervals throughout a complete tidal cycle, with photographs 14-26, which show similar information for the recommended channel enlargement, indicates that the enlarged channel would cause no significant changes in surface flow patterns and velocities. In these photographs, the velocity of the surface current in feet per second prototype in any area of the channel can be determined by measuring the length of a confetti streak in inches and multiplying by 2.64. This factor takes into consideration the scale of the photographs and the model-to-prototype scale relations for distance, time, and velocity.

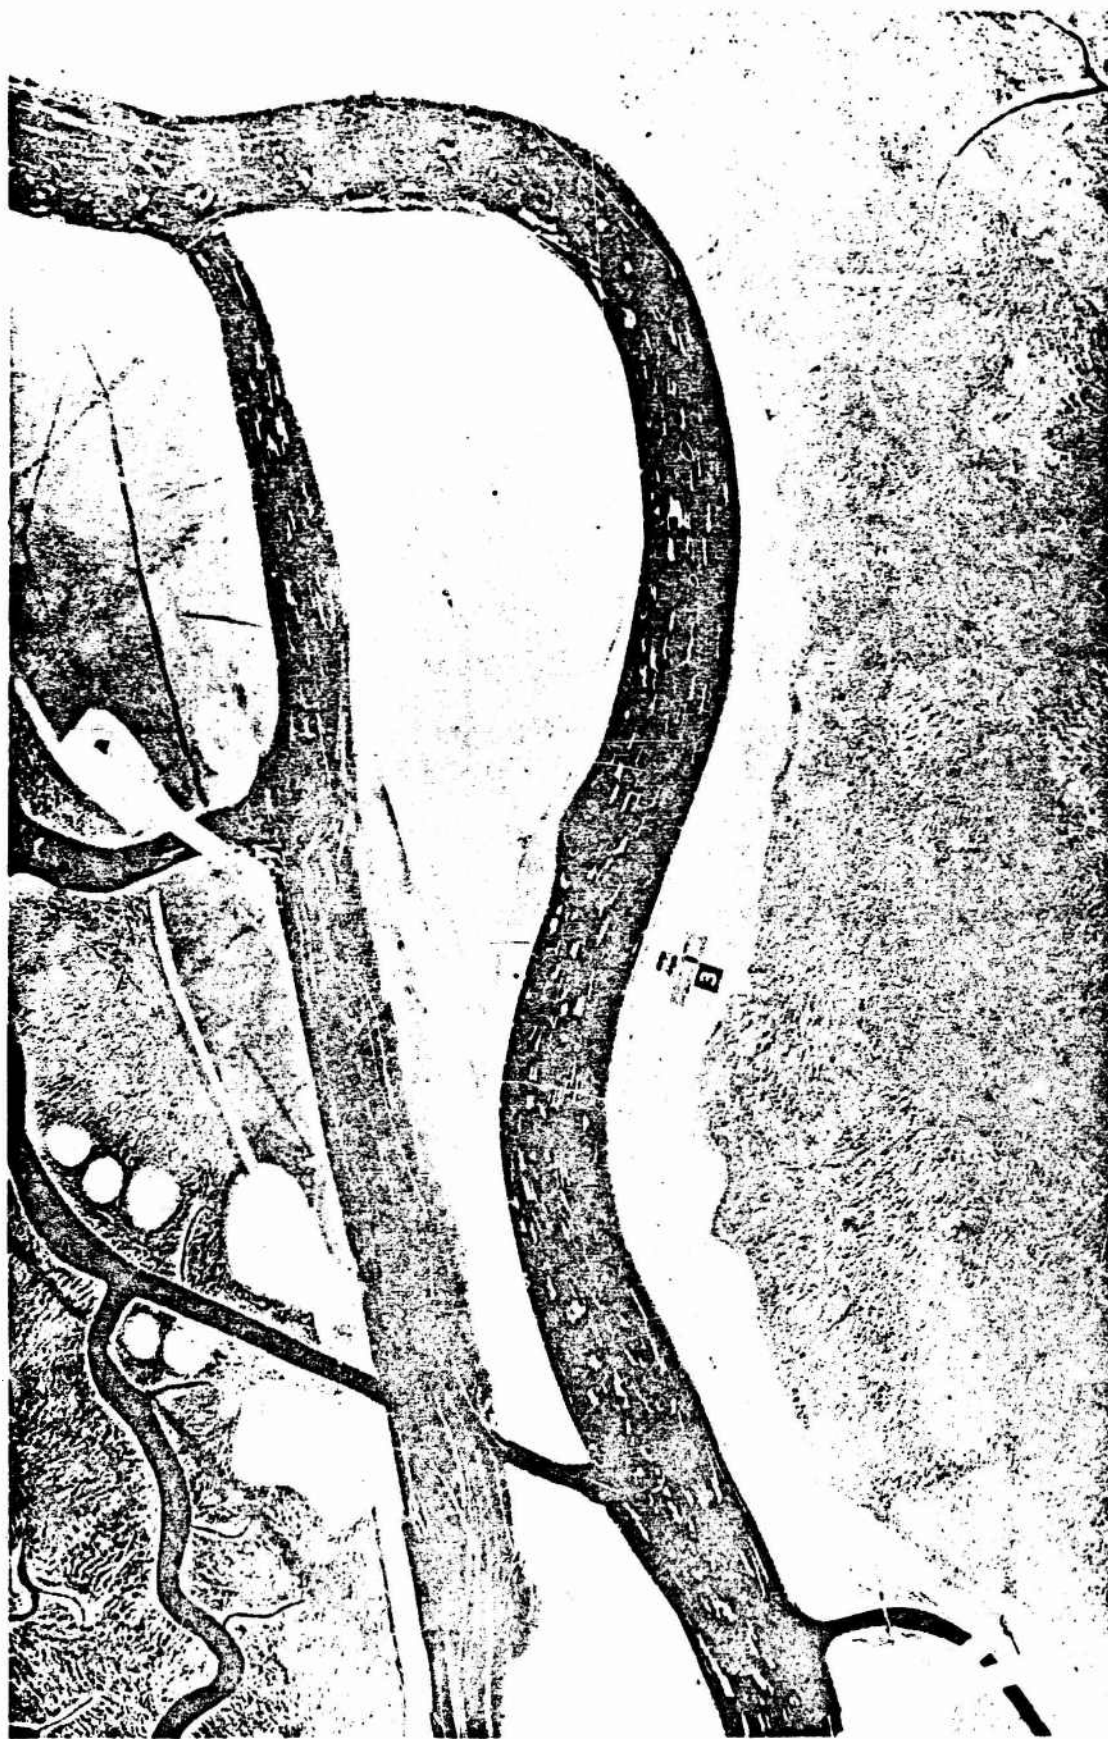
Photograph 4. Surface current directions and velocities for 1964 channel conditions. Hour 3, ebb tide

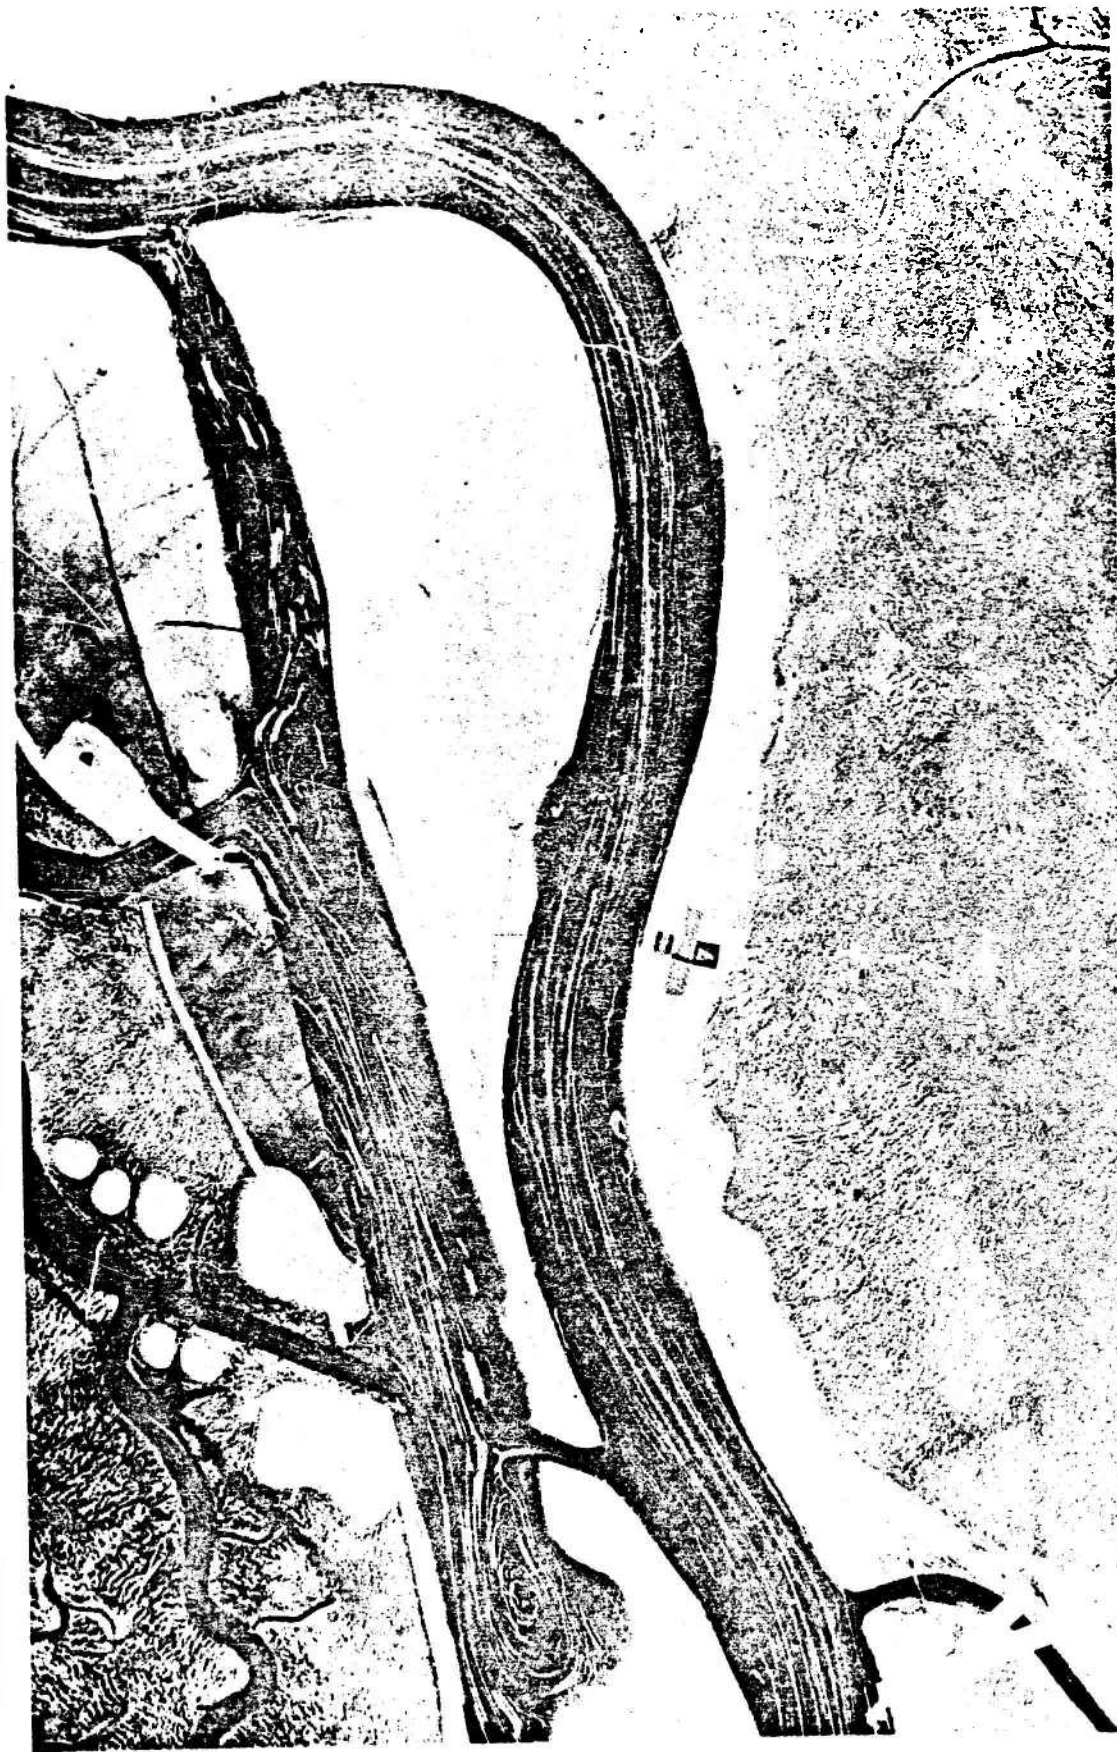
Photograph 8. Surface current directions and velocities for 1964 channel conditions. Hour 7, flood tide

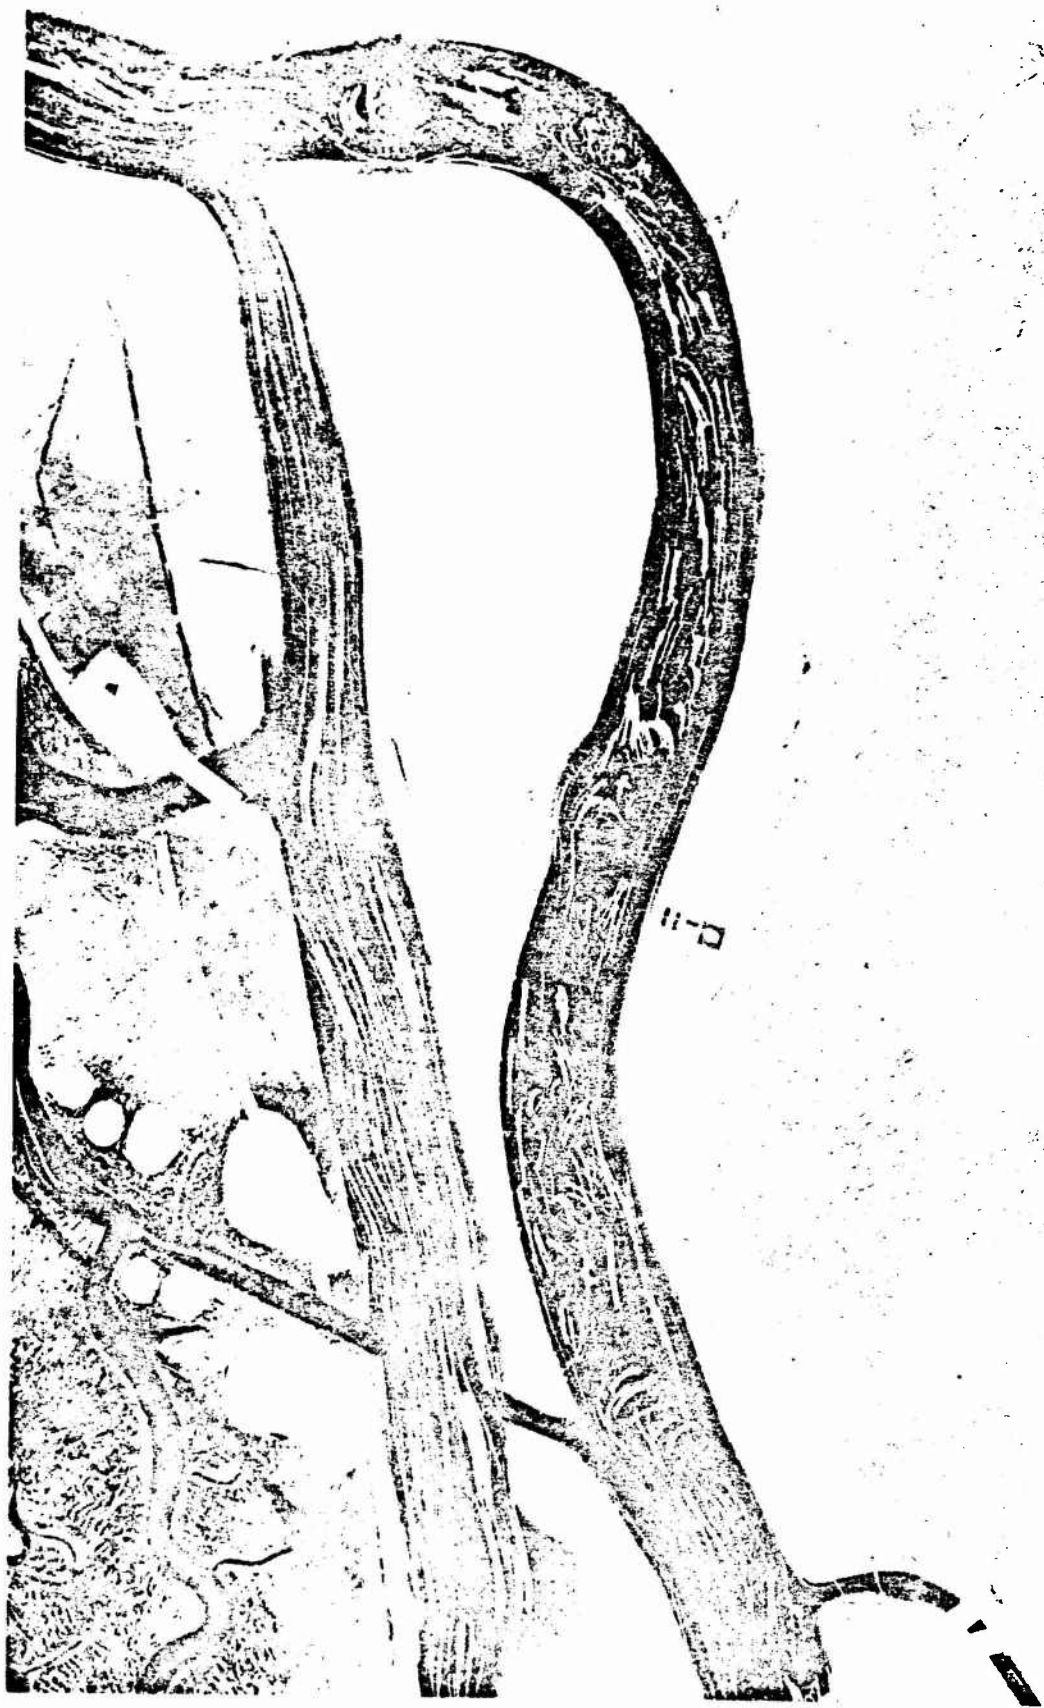
Photograph 10. Surface current directions and velocities for 1964 channel conditions. Hour 9, ebb tide

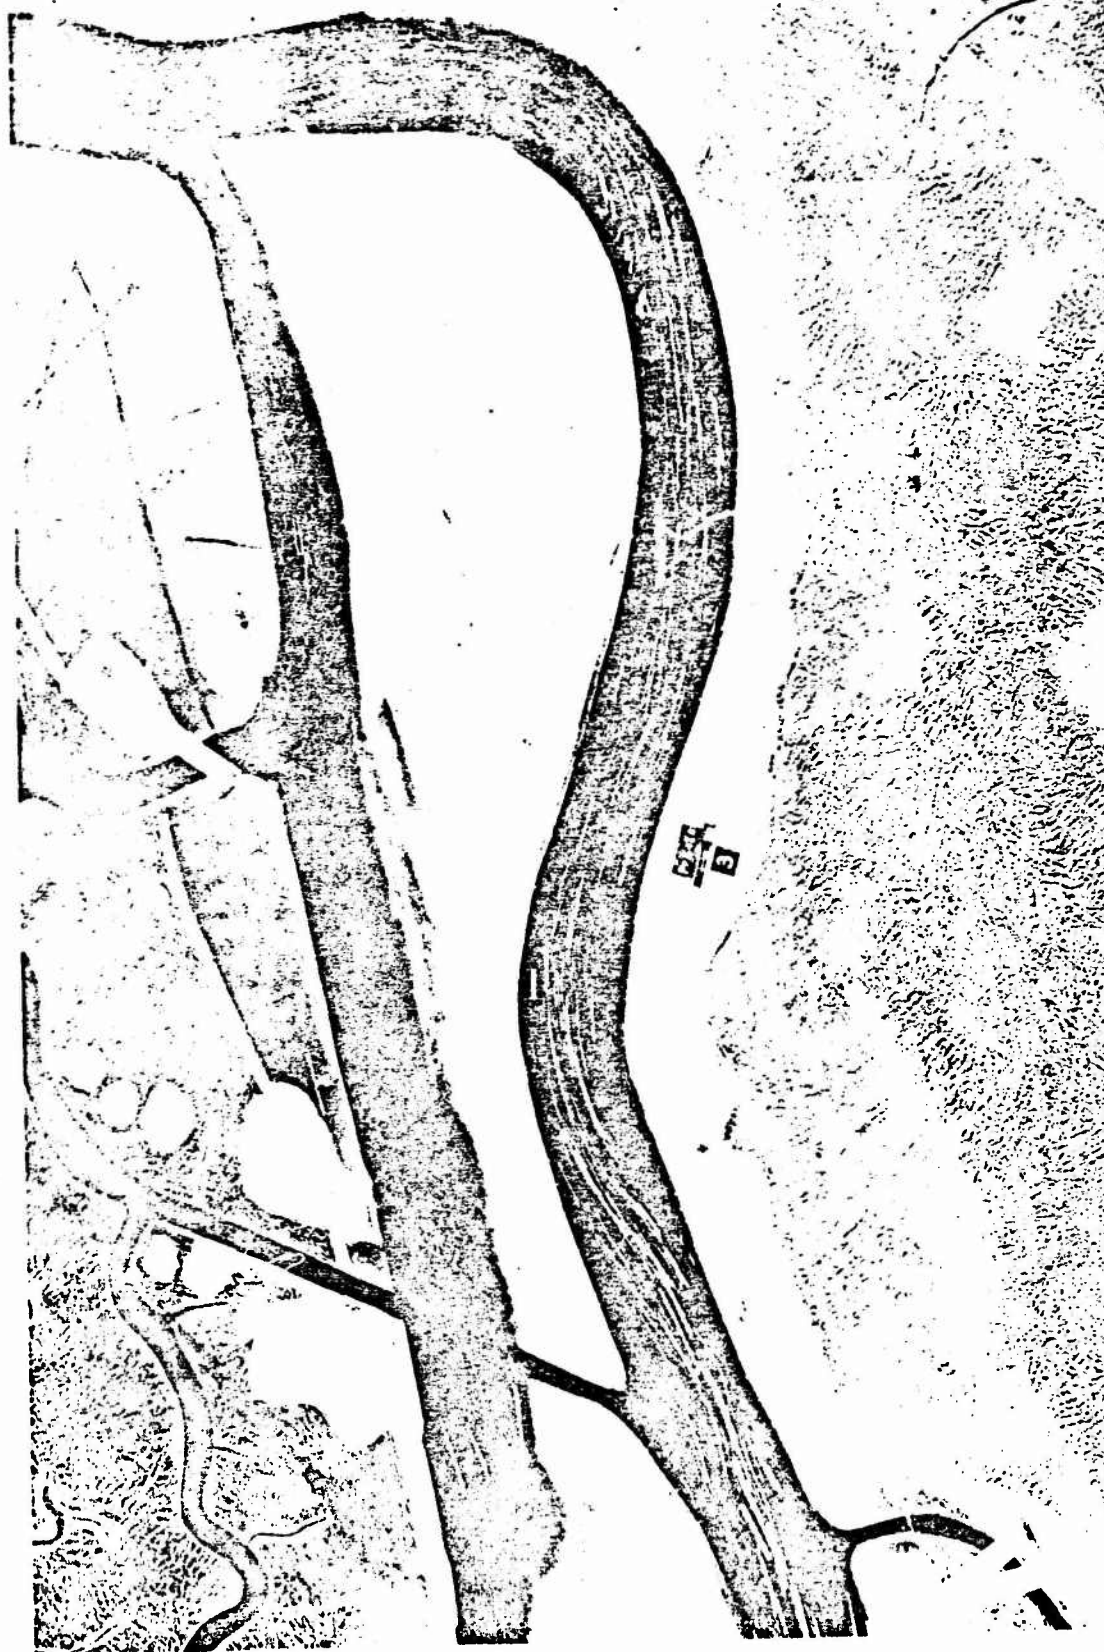
Photograph 17. Surface current directions and velocities for recommended channel enlargement.  
Hour 3, ebb tide

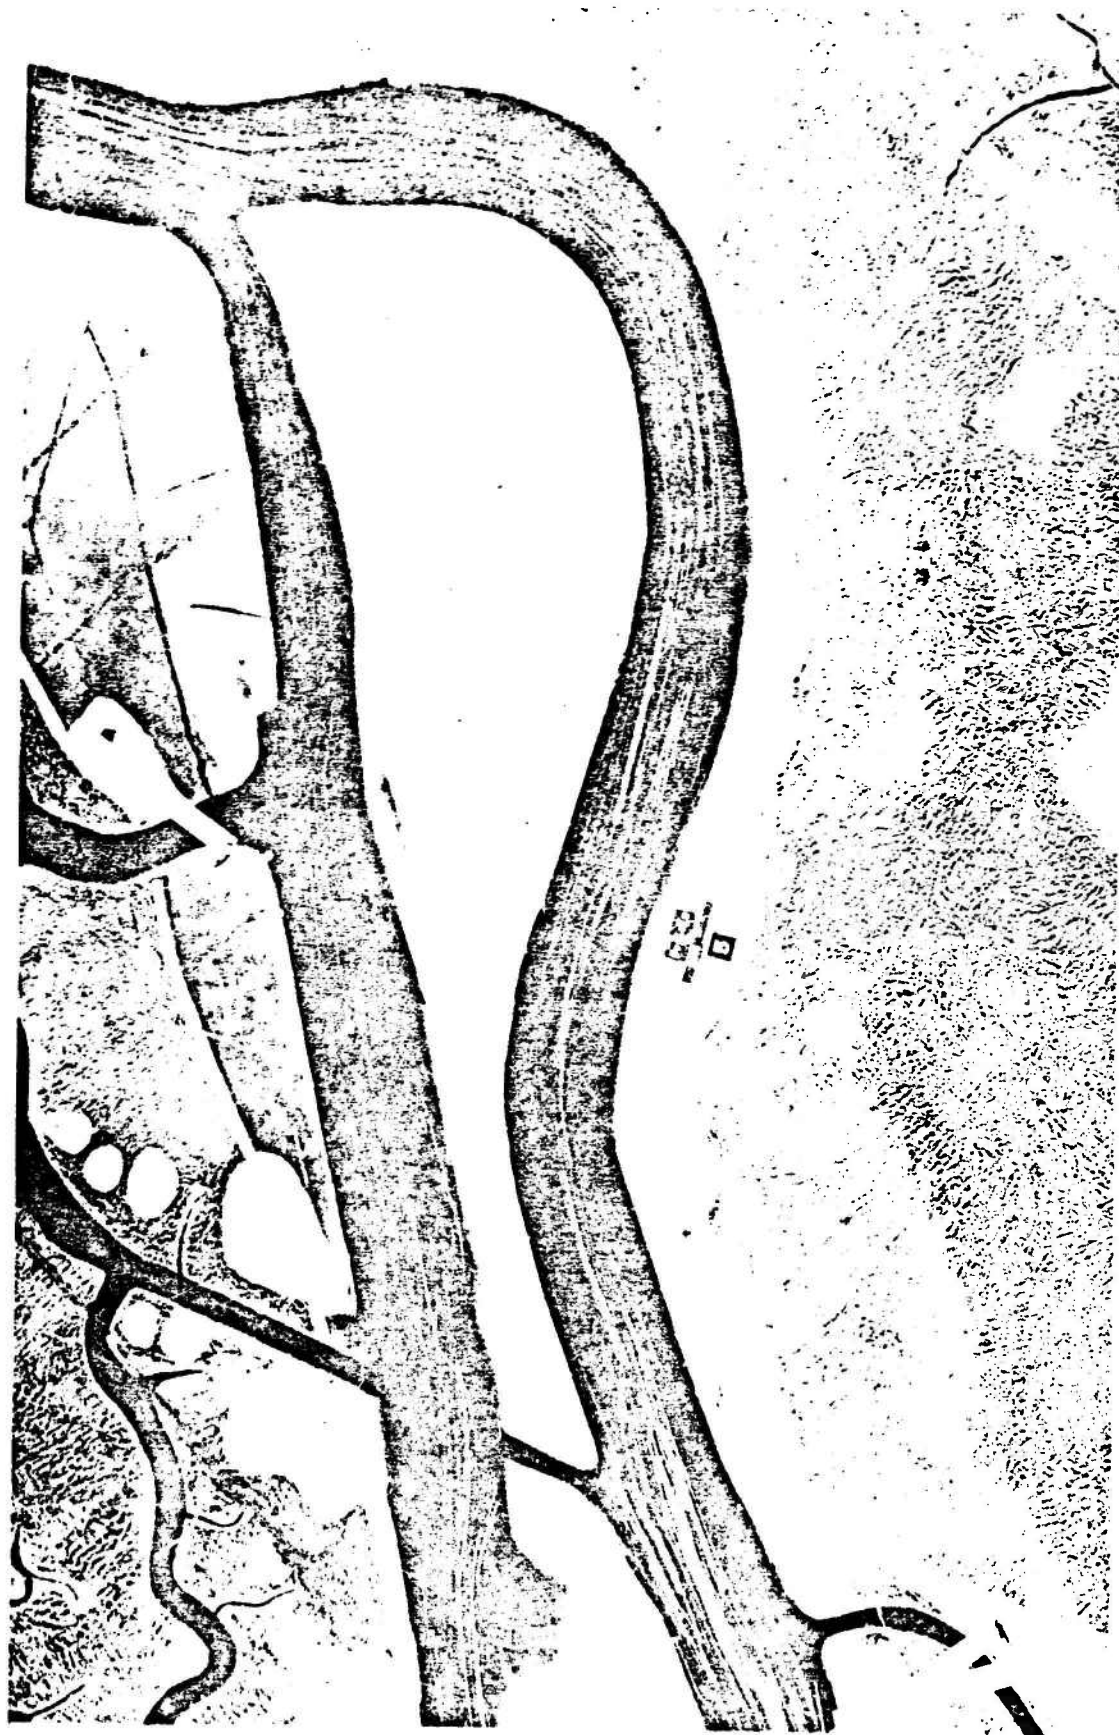
Photograph 19. Surface current directions and velocities for recommended channel enlargement.  
Hour 5, flood tide

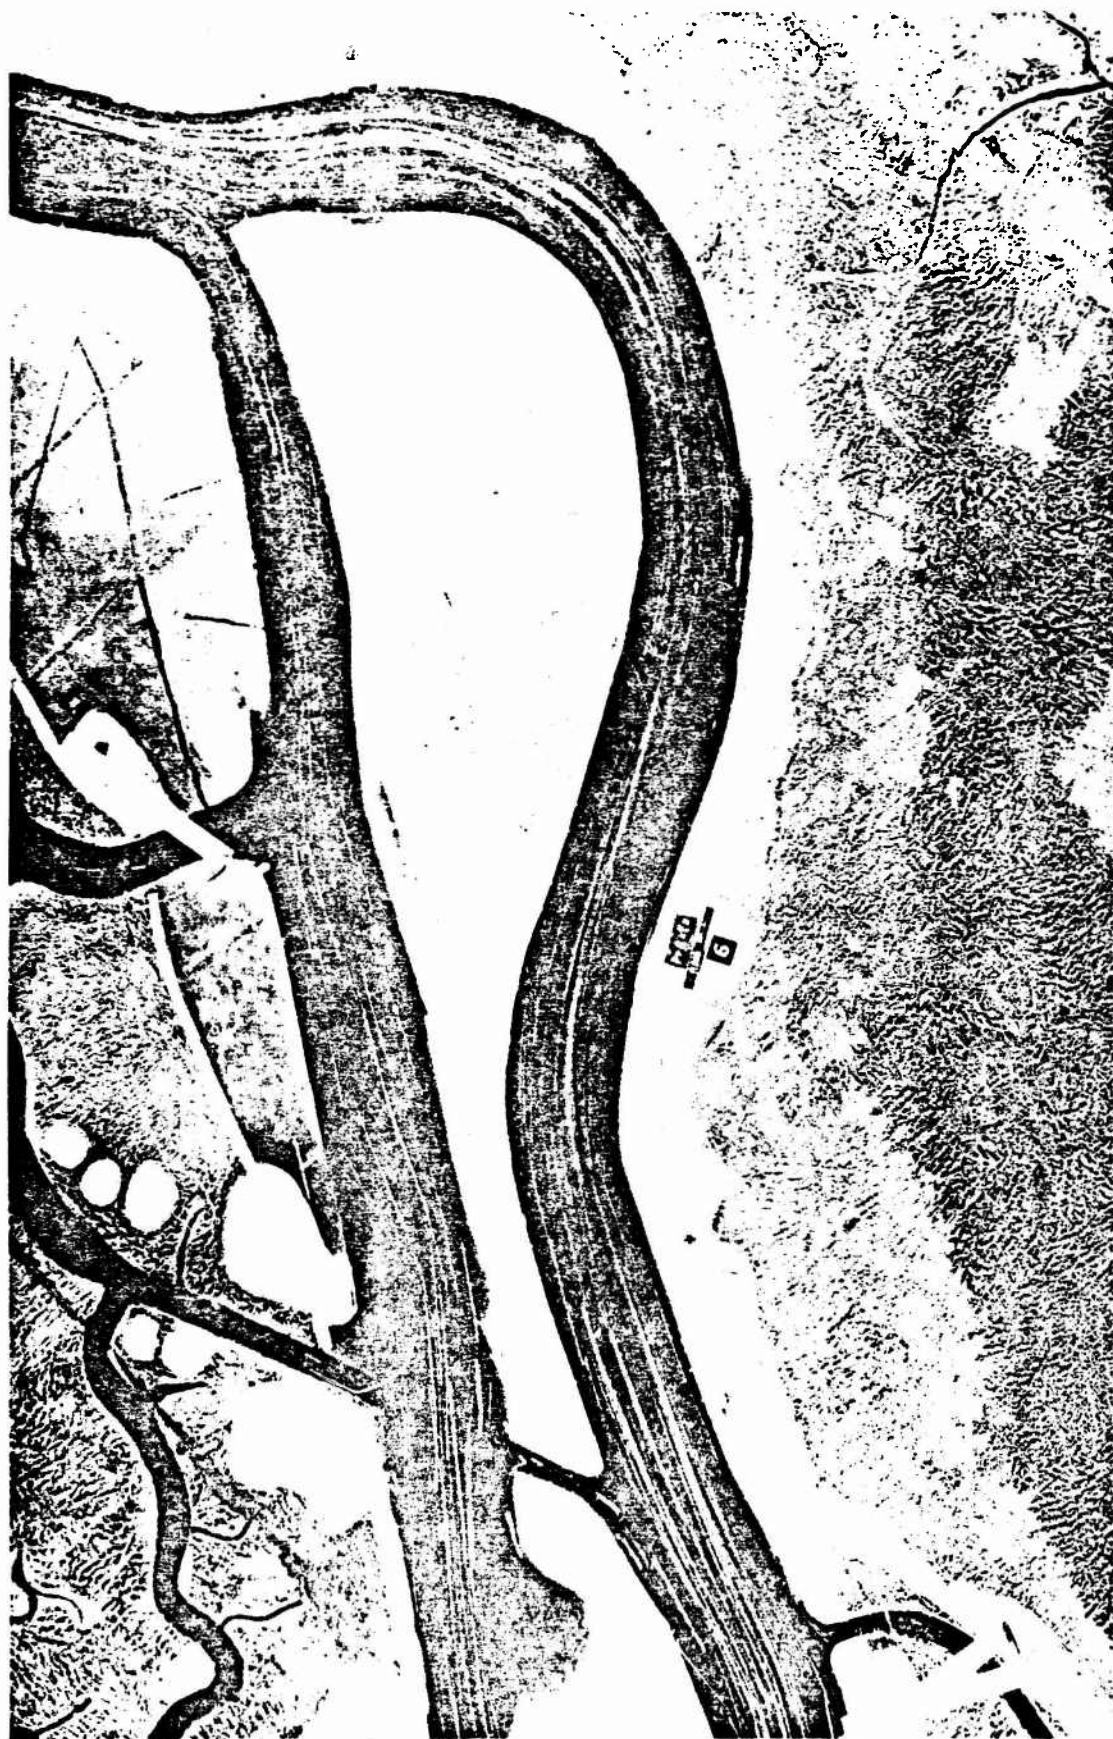
Photograph 20. Surface current directions and velocities for recommended channel enlargement.  
Hour 6, flood tide

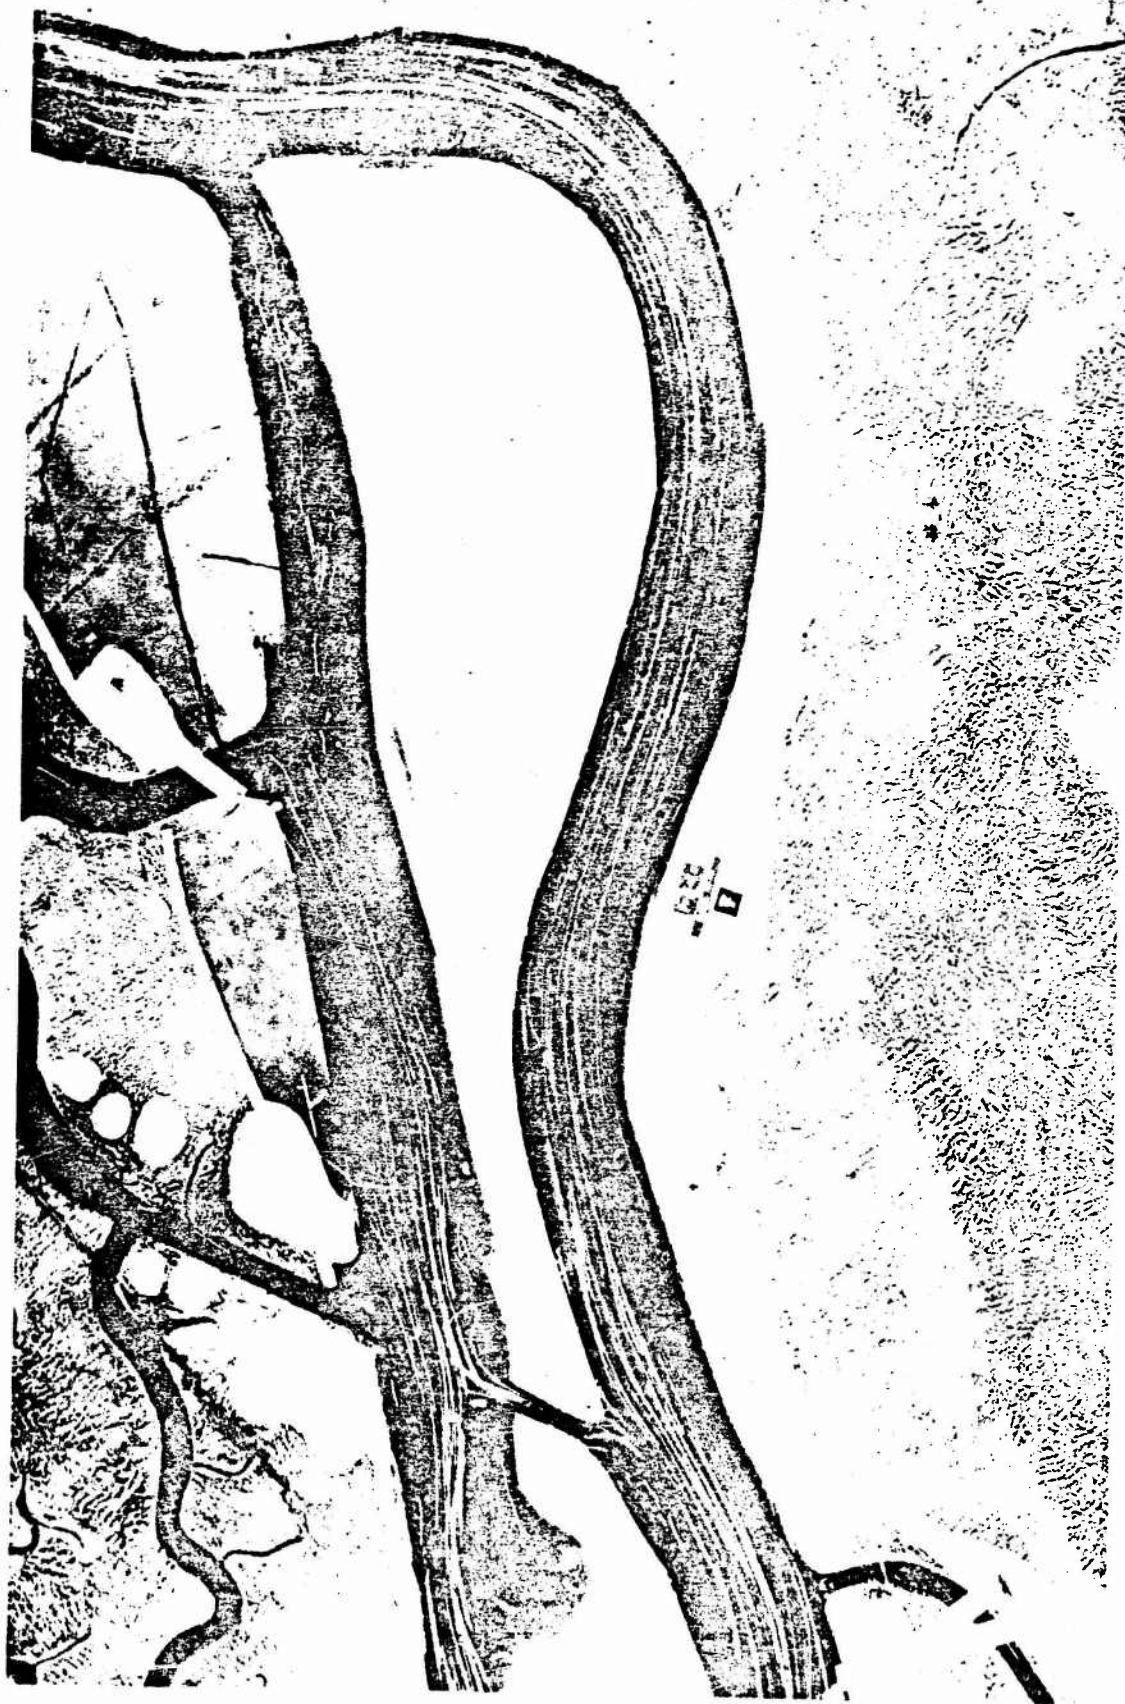
Photograph 21. Surface current directions and velocities for recommended channel enlargement.  
Hour 7, flood tide

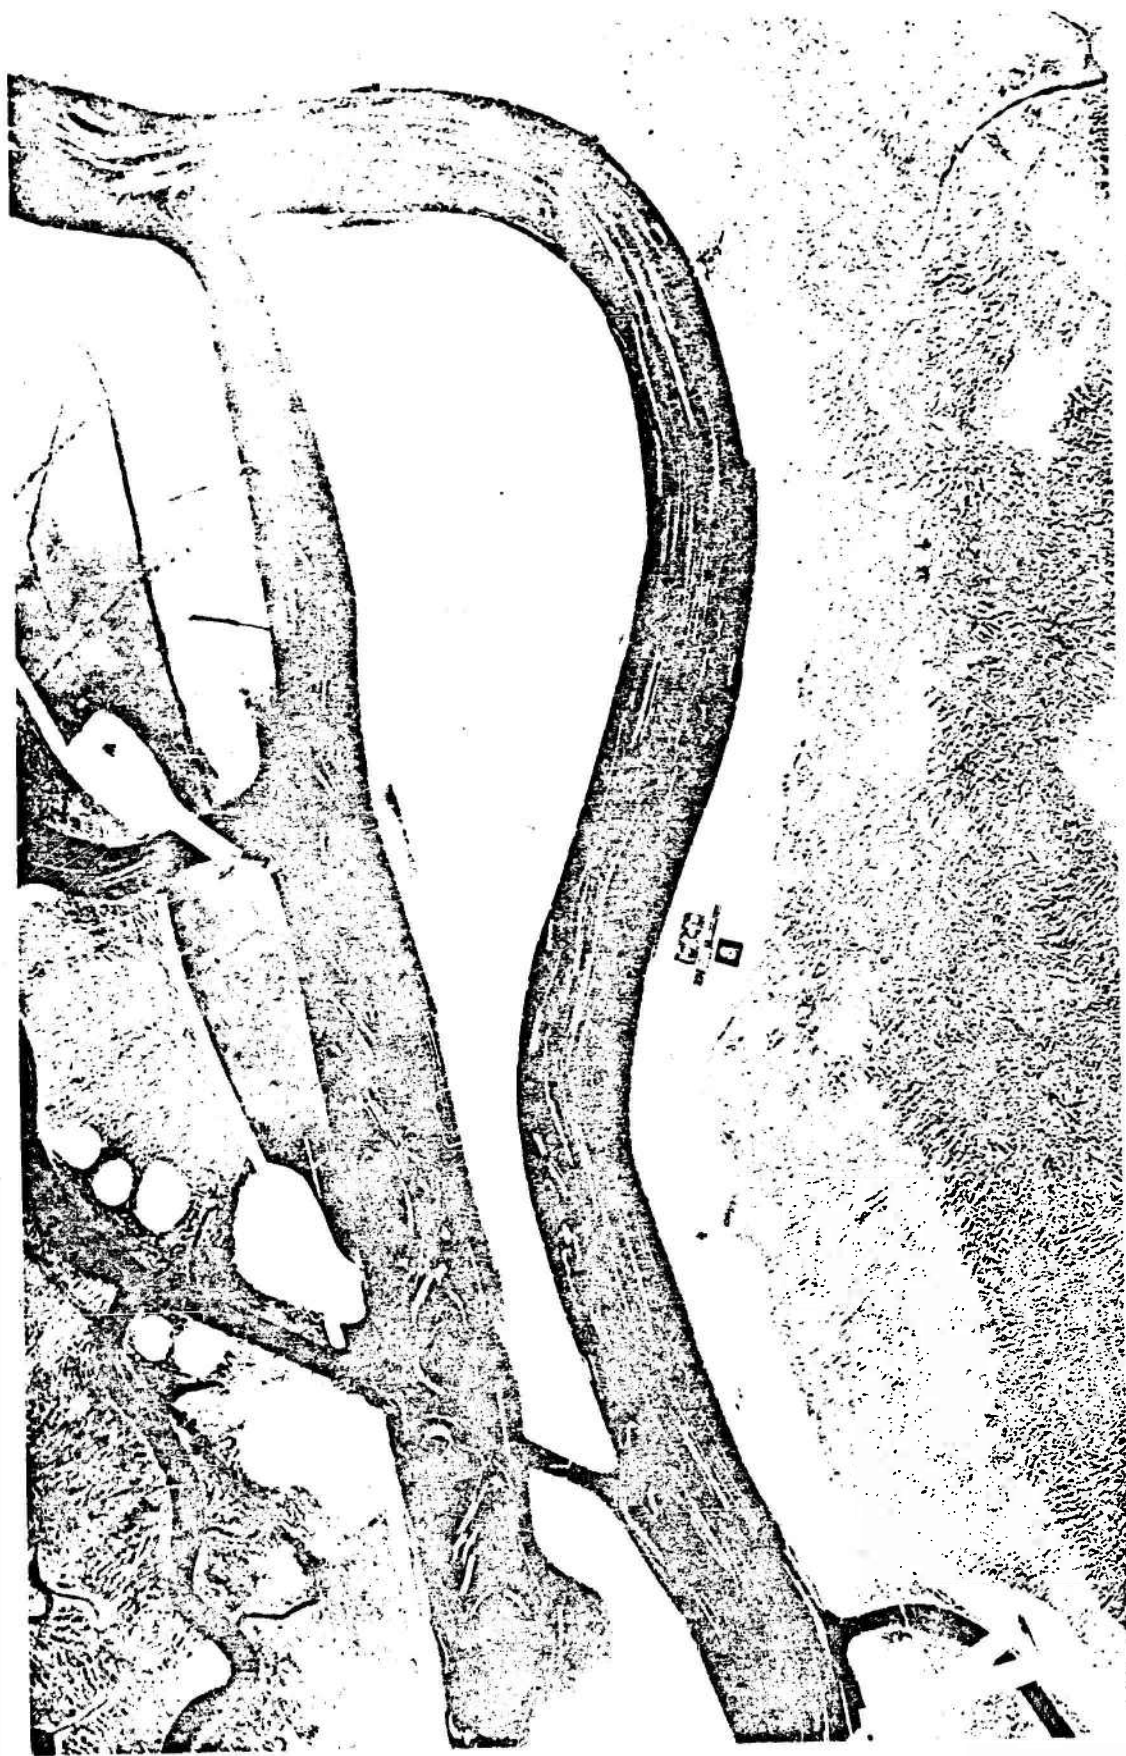
Photograph 22. Surface current directions and velocities for recommended channel enlargement.  
Hour 8, flood tide

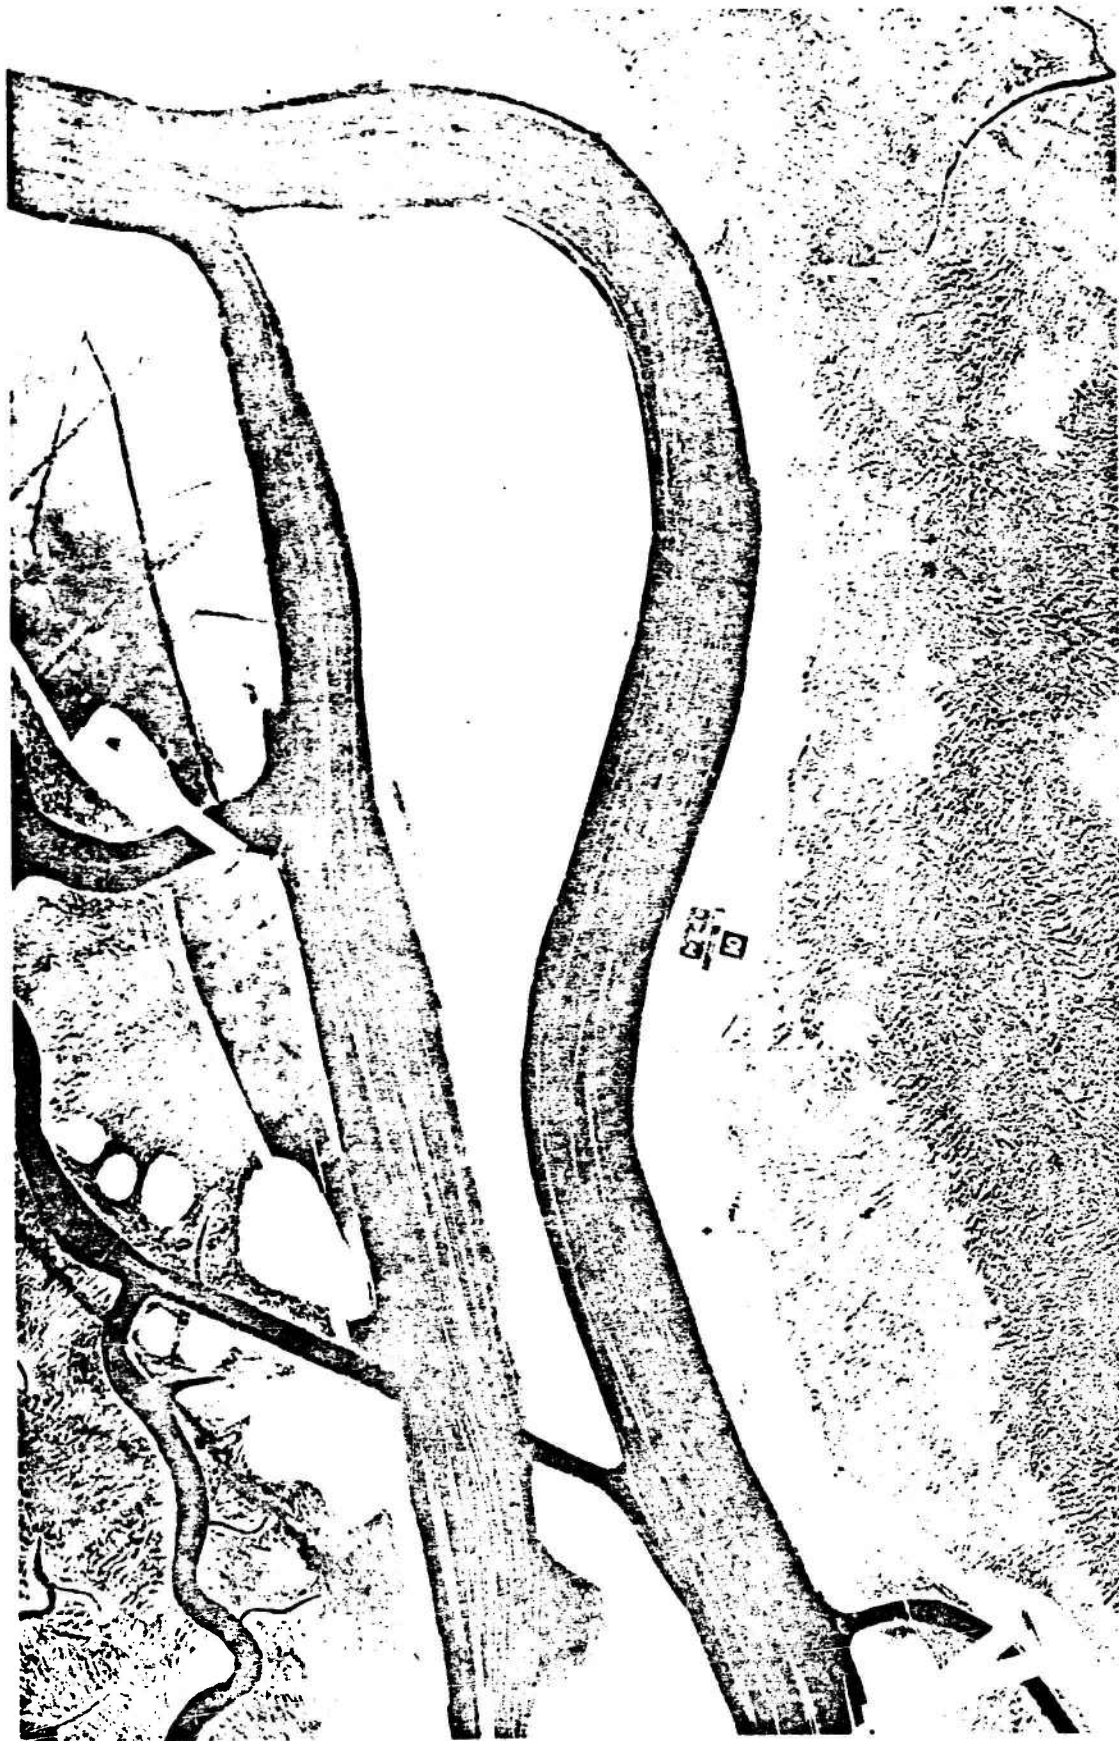
Photograph 24. Surface current directions and velocities for recommended channel enlargement.  
Hour 10, ebb tide

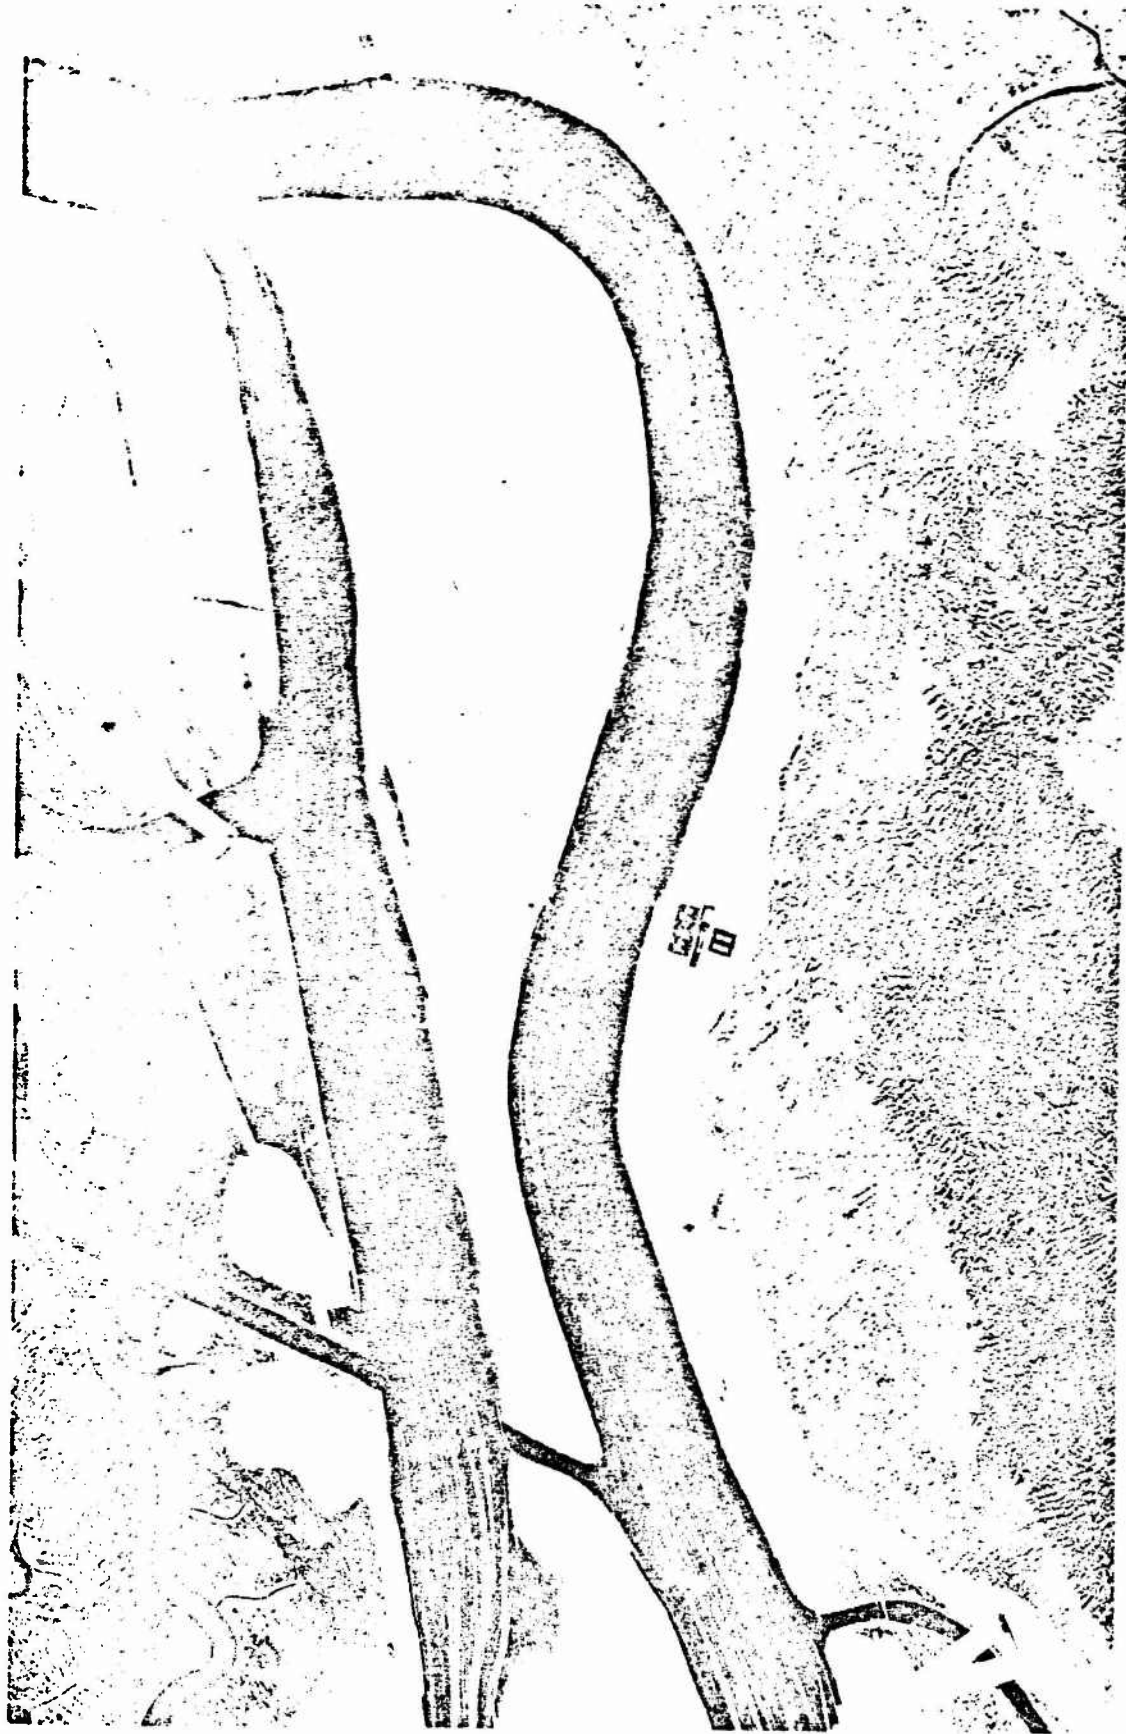
Photograph 25. Surface current directions and velocities for recommended channel enlargement.  
Hour 11, ebb tide
